Reflective Cracking Construction Notes

Date: January 12, 2015

Project: Reflective Cracking Indoor Phase IV

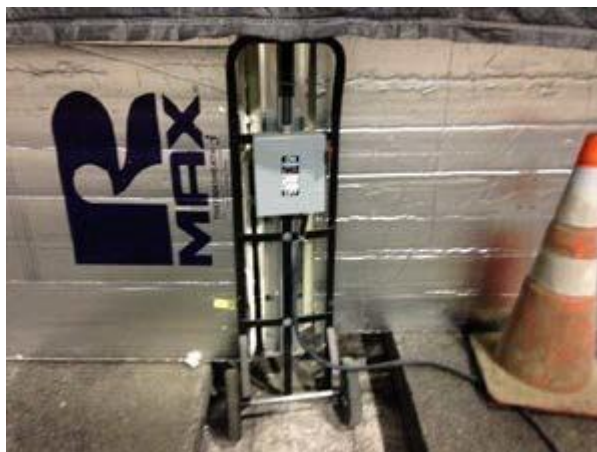
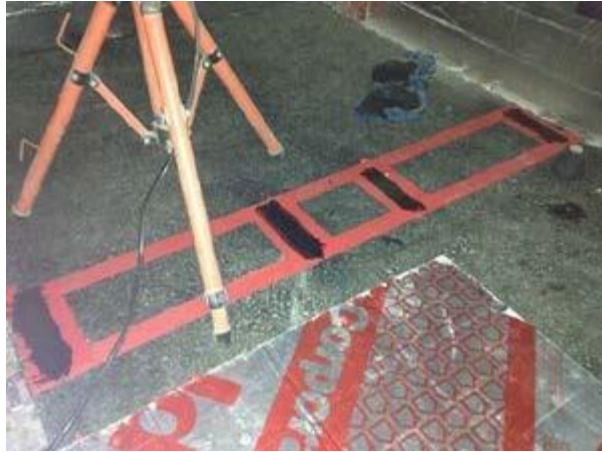
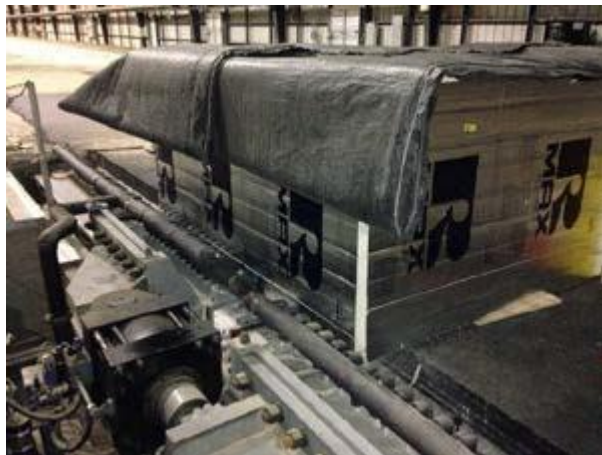
Figure 1. Environmental Test Chamber.

SRA engineers and technicians constructed an environmental chamber, as shown in Figure 1, atop the test rig to completely cover the joint and surrounding areas. The environmental chamber was constructed using insulated foam panels that were cut as needed to fit and taped together to form an enclosure approximately 14 feet long, 8 feet wide, and 4 feet high. A concrete curing blanket was also placed atop the enclosure to provide additional insulation. An opening was left in the West side of the chamber to accommodate the placement of an upright radiant heater which will be used to raise the temperature of the test rig surface within the chamber and maintain favorable conditions for the placement and curing of adhesive for the surface strain gauges.
